TAR RUN DAM
NDS ID NO. PA-00692
DER ID NO. 54-124

SCHUYLKILL COUNTY MUNICIPAL AUTHORITY

PHASE I INSPECTION REPORT
NATIONAL DAM INSPECTION PROGRAM

AUGUST 1978

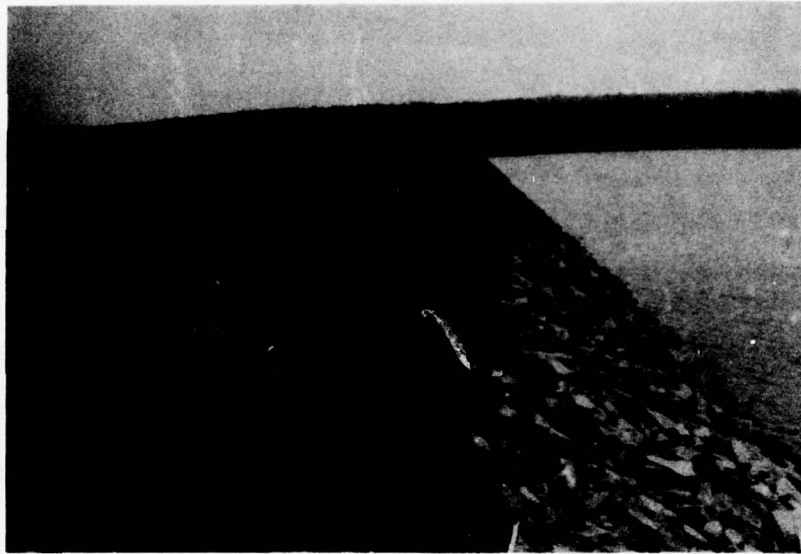
The riprap protection on the upstream slope of the embankment has a top elevation which varies between Elevations 1527.1 and 1528.5, as determined by a survey performed for this inspection (Photograph A). The top of riprap on the downstream slope is generally about 1 foot lower than top of embankment.

A. Riprap on Upstream Slope of Embankment.

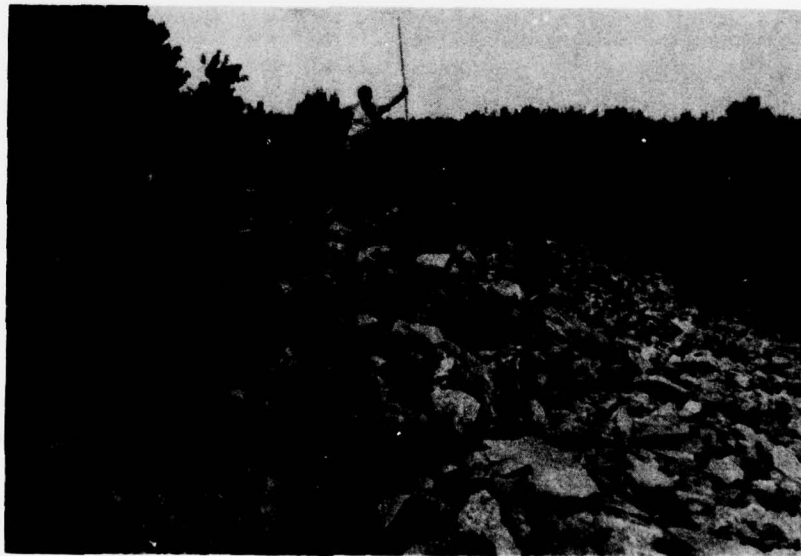
The riprap on the downstream slope is very loose with many uneven areas. It slid underfoot when an inspector walked on it. The uneven areas appear to be slides.

The bulges on the riprap on the downstream slope were thought to be surface sliding of the loose riprap, with no sliding of the embankment beneath. The sliding could, however, be an indication of more serious problems.

D. Riprap on Downstream Slope of Embankment.

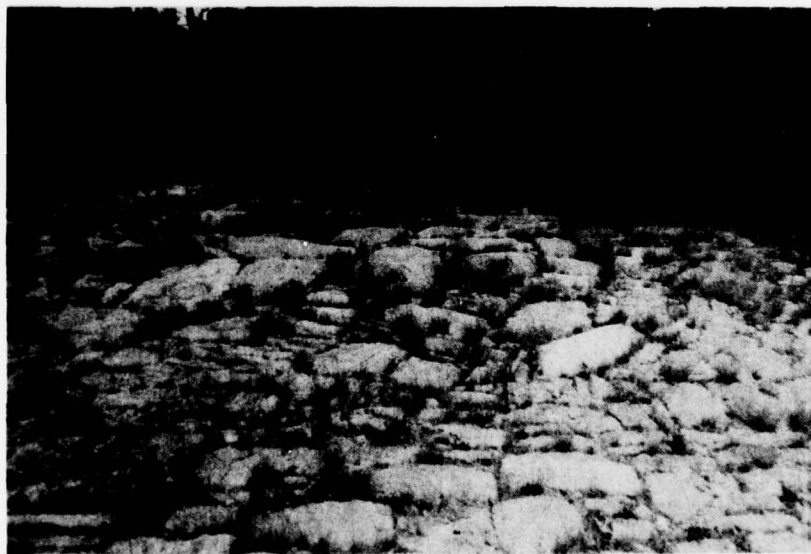
A small amount of grass is growing in the dry masonry apron downstream of the weir (Photograph H). One 3-foot square of masonry is missing. The downstream end of the apron is eroded and undermined. Downstream of the spillway training walls, the walls along the apron are 1.4-feet high (Photograph G).

The vegetation in the masonry apron is sufficiently small to be of no concern at present. The missing masonry may allow high spillway discharges to unravel the remaining masonry. The low spillway walls immediately beyond the toe of embankment are of some concern, as flow over the wall on the left would flow down the embankment, creating an erosion hazard. This condition is evaluated further in Section 5.

H. Spillway Outlet Channel — Looking Downstream.

(7) Replace missing stones in spillway apron.

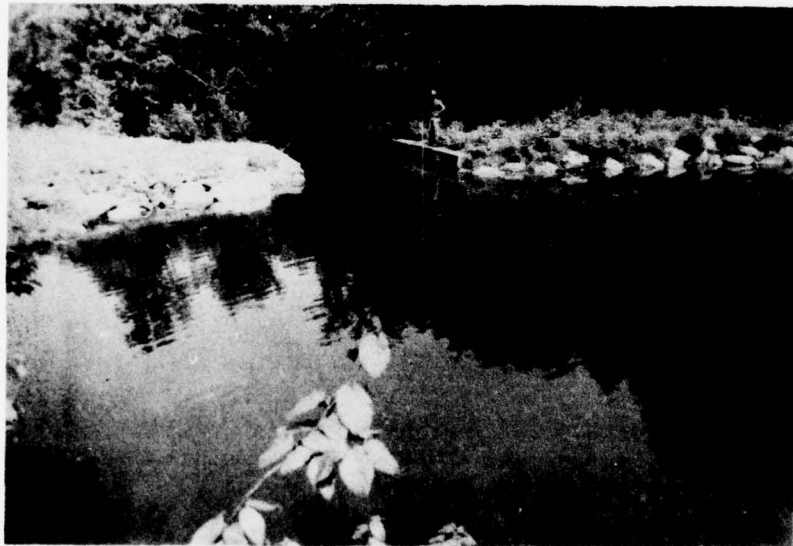
e. Downstream Conditions. Tar Run Dam is 2.8 miles northwest of St. Clair, Pennsylvania, as shown on Plate 1. Flows from Tar Run Dam proceed downstream about 0.6 mile to a small dam (Photograph L). Although part of the Owner's system,

L. Small Dam Between Tar Run Dam
and Tar Run Intake Dam.
